AFRL-VA-WP-TR-2003-3088

**INVESTIGATION OF THE EFFECT OF
CORROSION PITTING ON FATIGUE
LIFE OF ALUMINUM STRUCTURE**

Eric J. Tuegel

OCTOBER 2003

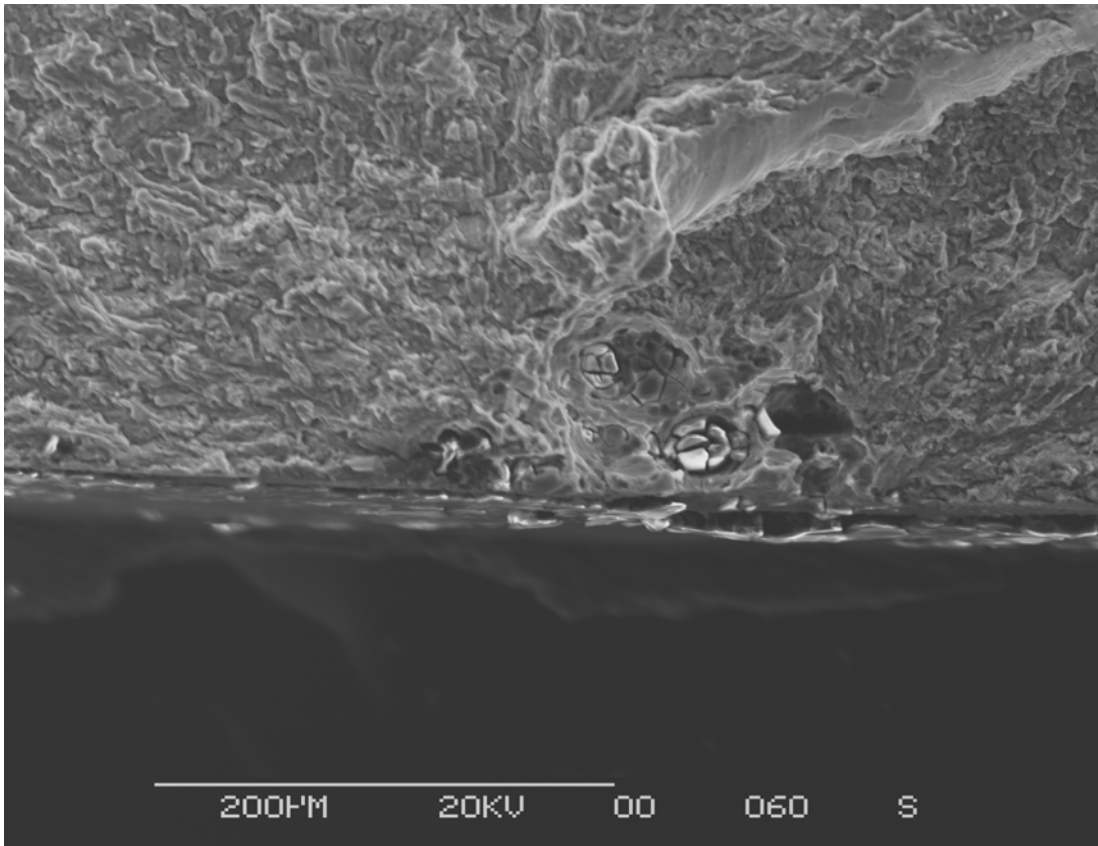
Figure B-4. Crack Origin A (Fig. B-3) on Specimen 1331.

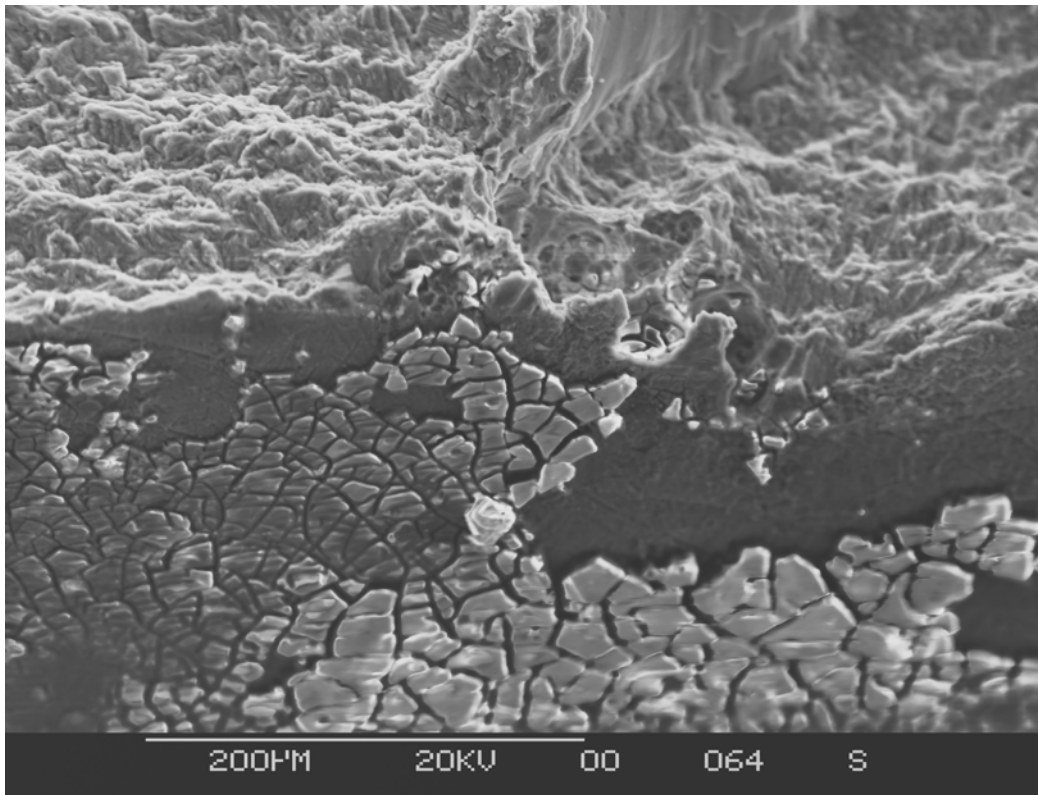
Figure B-5. Surface View of Crack Origin A (Fig. B-3) on Specimen 1331.

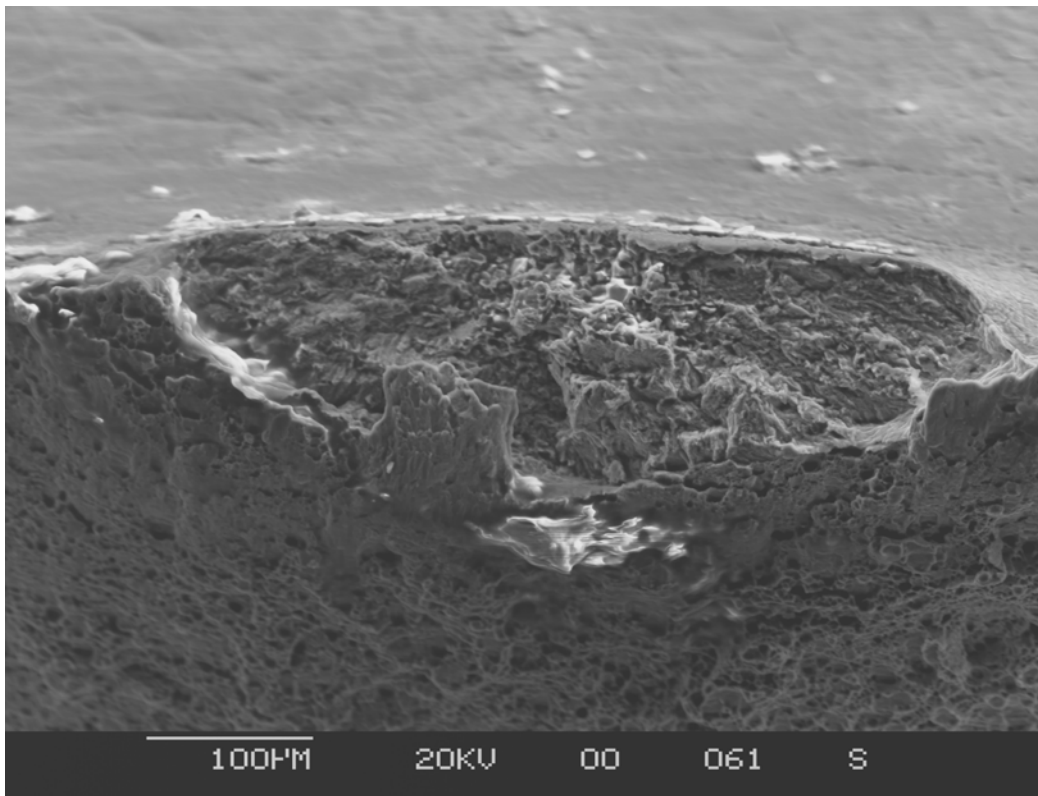
Figure B-6. Feature B (Fig. B-3) on Fracture Surface of Specimen 1331.

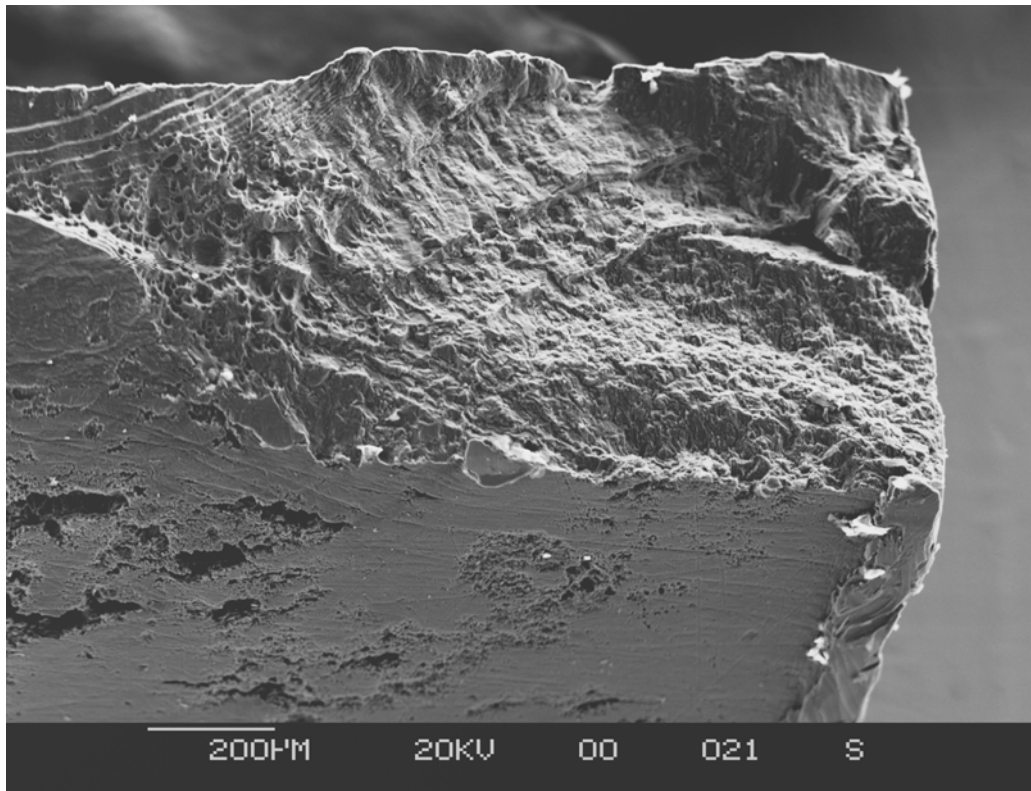
Figure B-9. Fatigue Crack on Fracture Surface of Specimen 5616.

One origin is at a pit, but the dominant crack seems to have come from the corner at lower right.

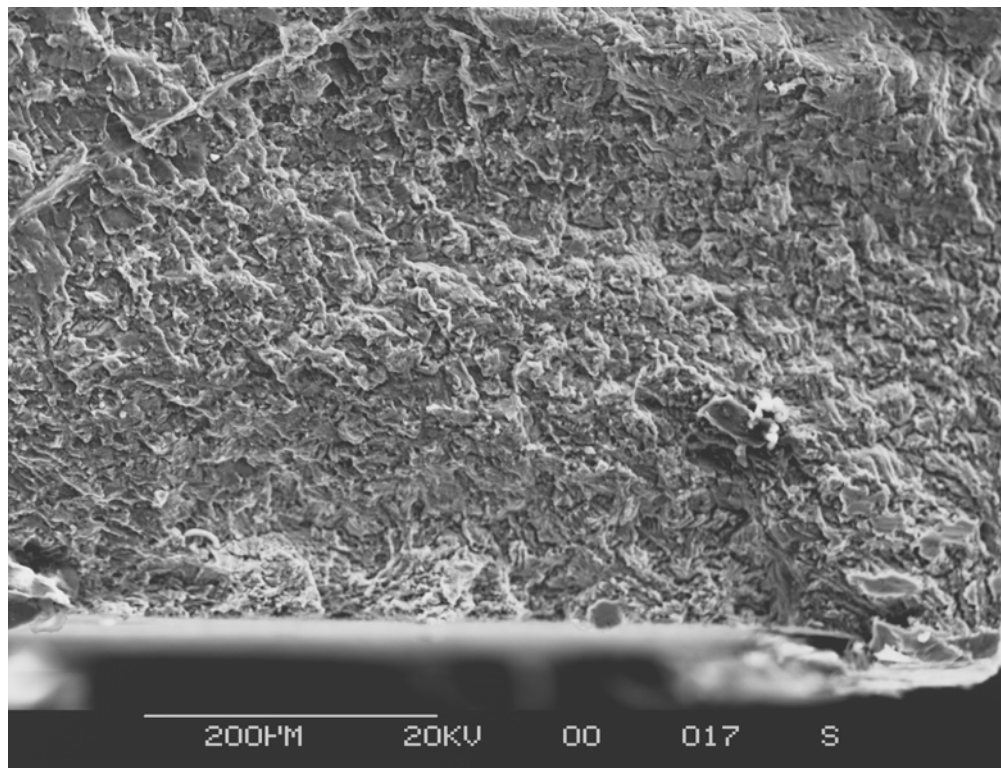
Figure B-10. Origin at Pit (Fig. B-9) on Specimen 5616.

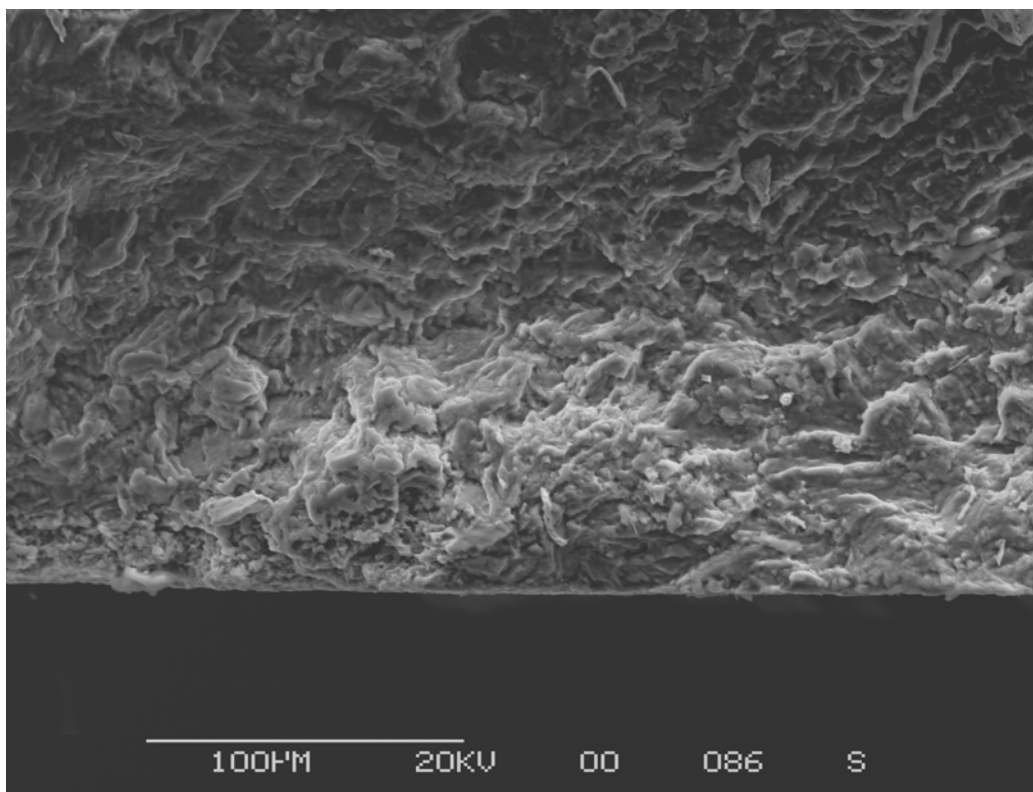
Figure B-13. Origin A (Fig. B-12) on Specimen 5618.

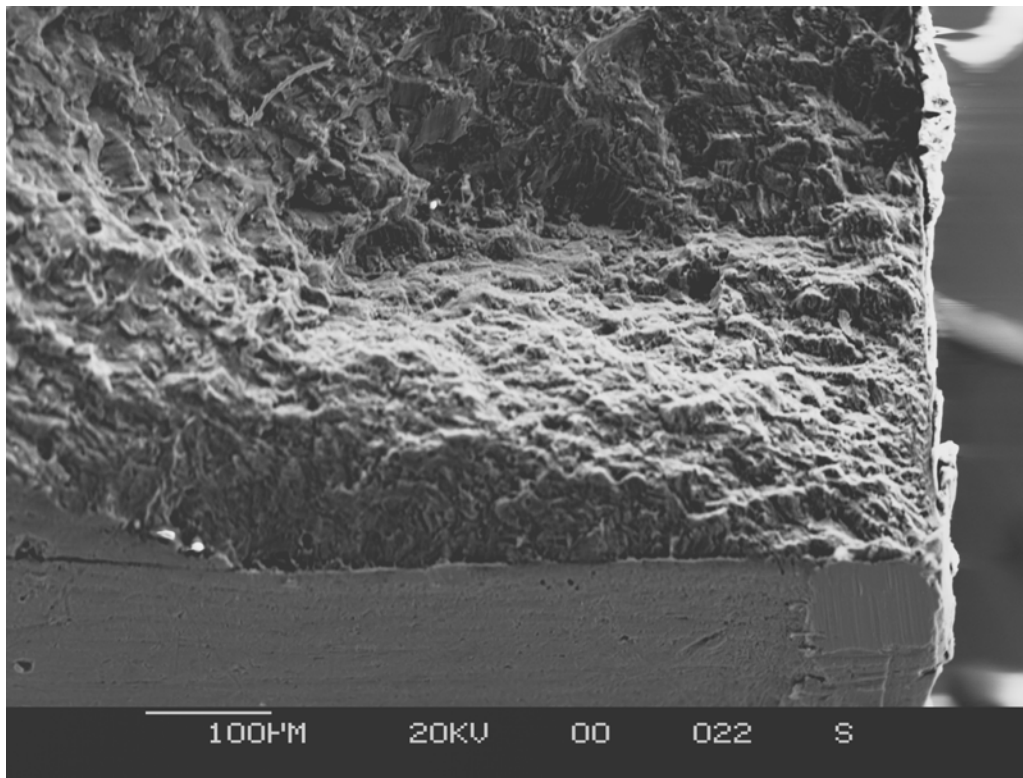
Figure B-17. Fatigue Crack on Fracture Surface of Specimen 5635.

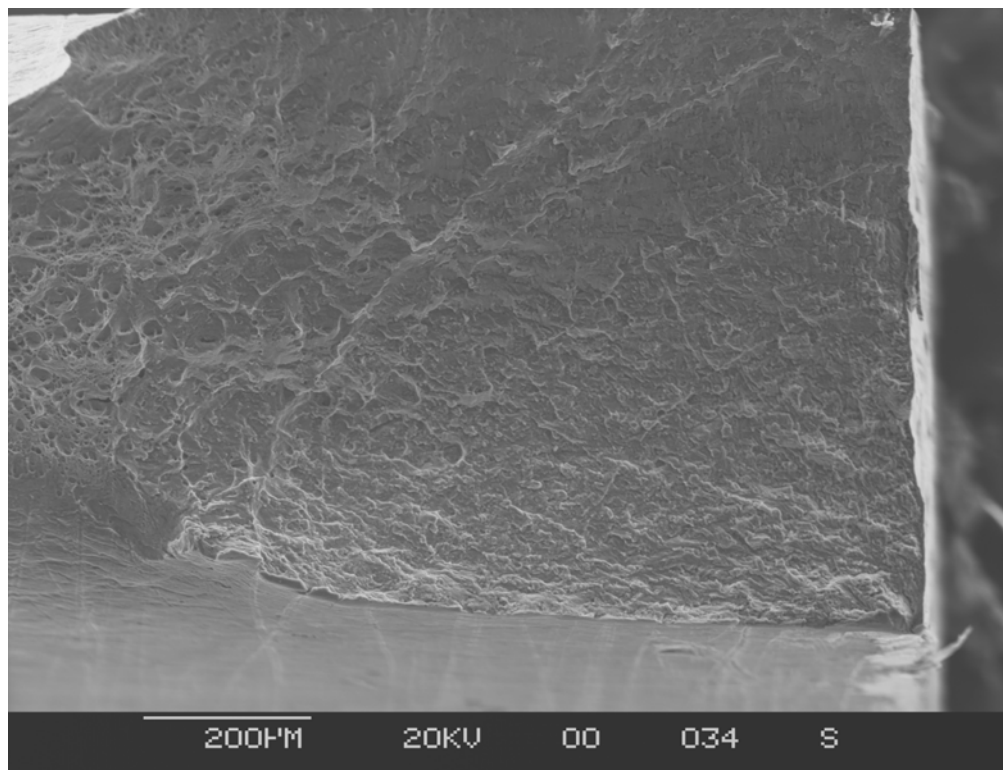
Figure B-18. Corner Fatigue Crack on Fracture Surface of Specimen 5636.

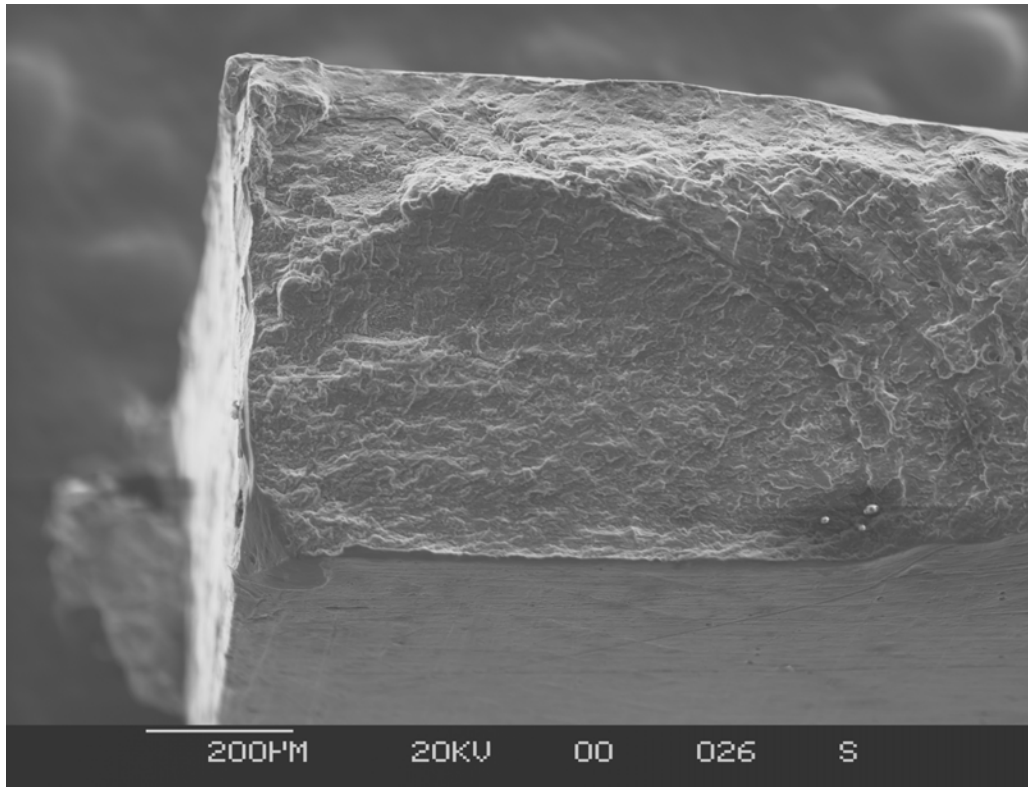
Figure B-22. Fatigue Crack on Fracture Surface of Specimen 5772.

Origin is at corner in lower left of photograph.

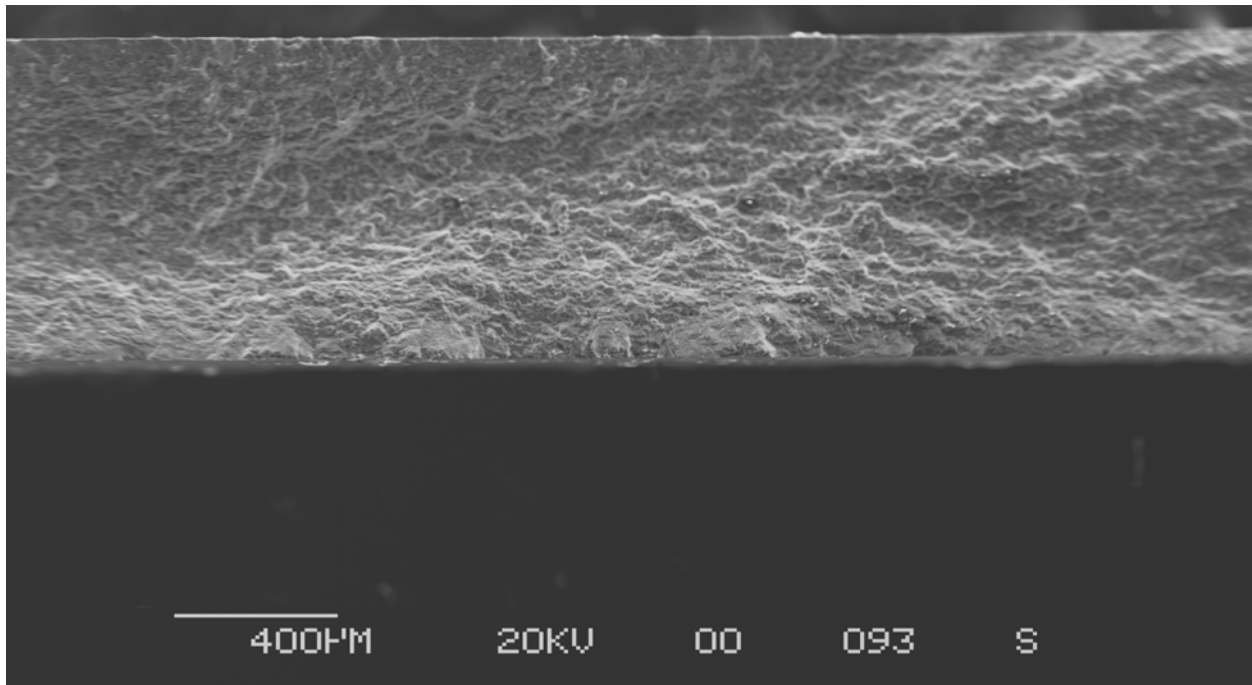
Figure B-28. Multiple Origins for Largest Crack on Specimen 5832.

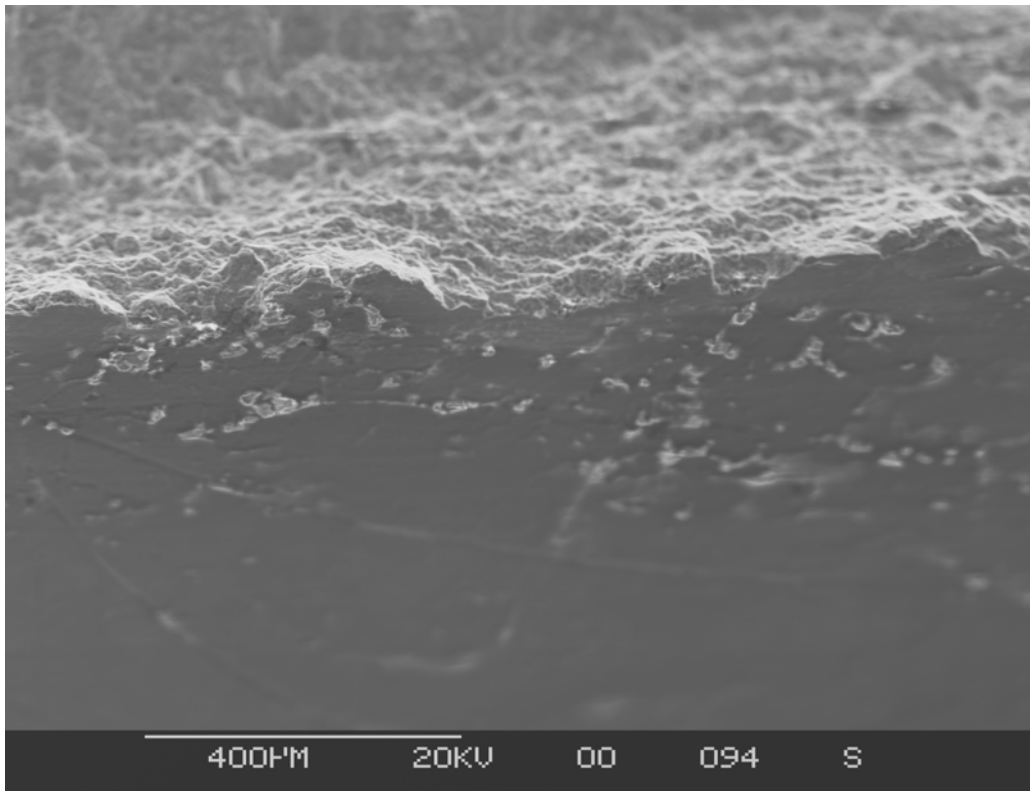
Figure B-29. Surface View of Crack Origins on Specimen 5832.

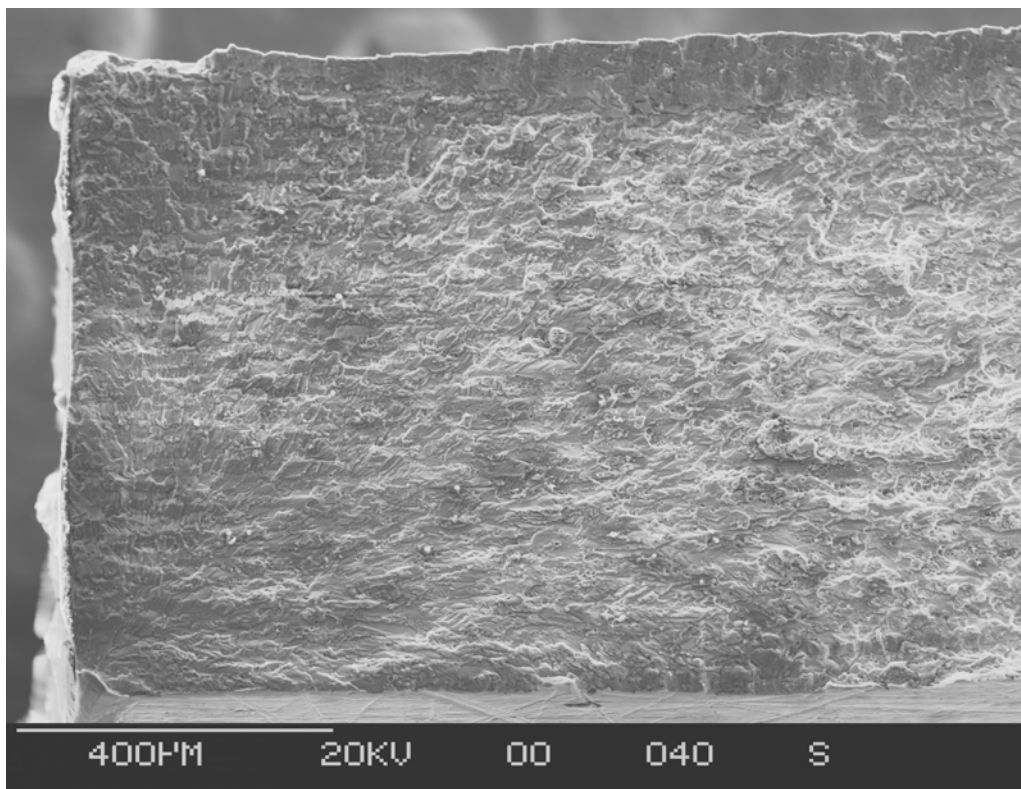
Figure B-30. Fatigue Crack on Fracture Surface of Specimen 5854.

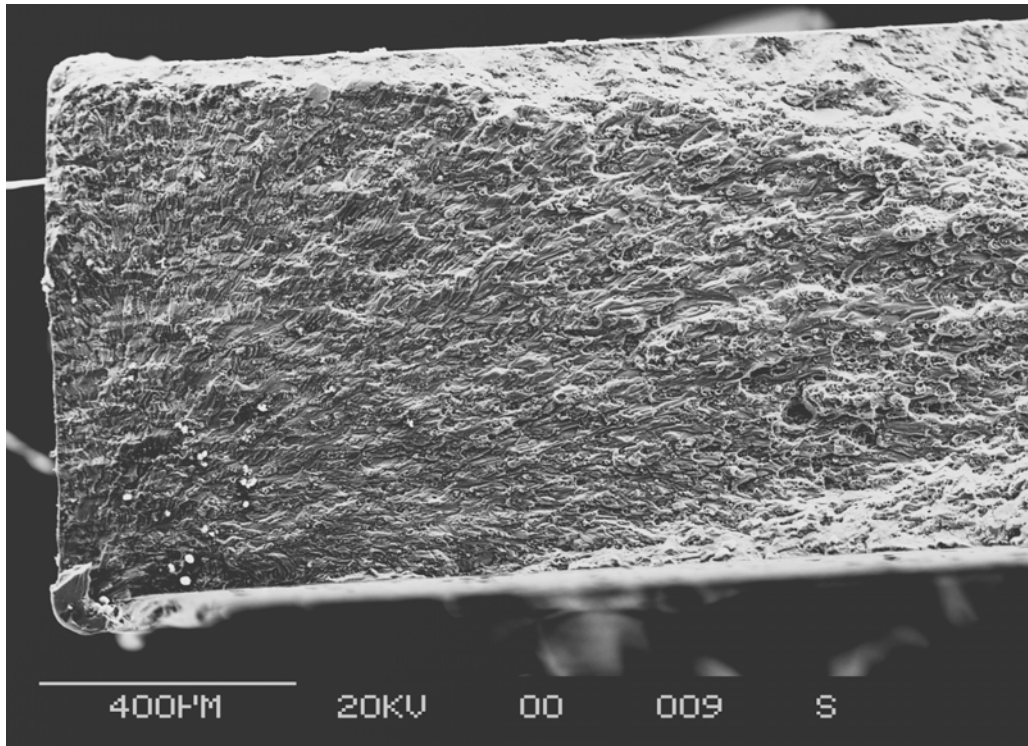
Figure B-31. Fatigue Crack on Fracture Surface of Specimen 5869.

Origin is at corner in lower left of photograph.

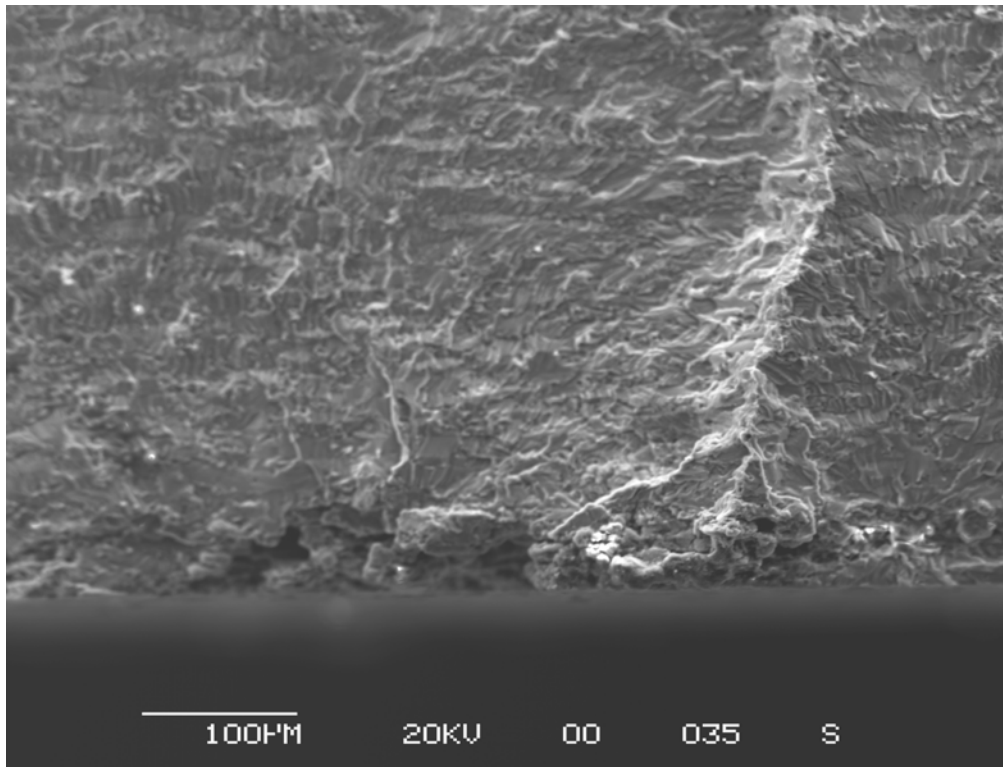
Figure B-35. Crack Origin B (Fig. B-34) on Fracture Surface of Specimen 5877.

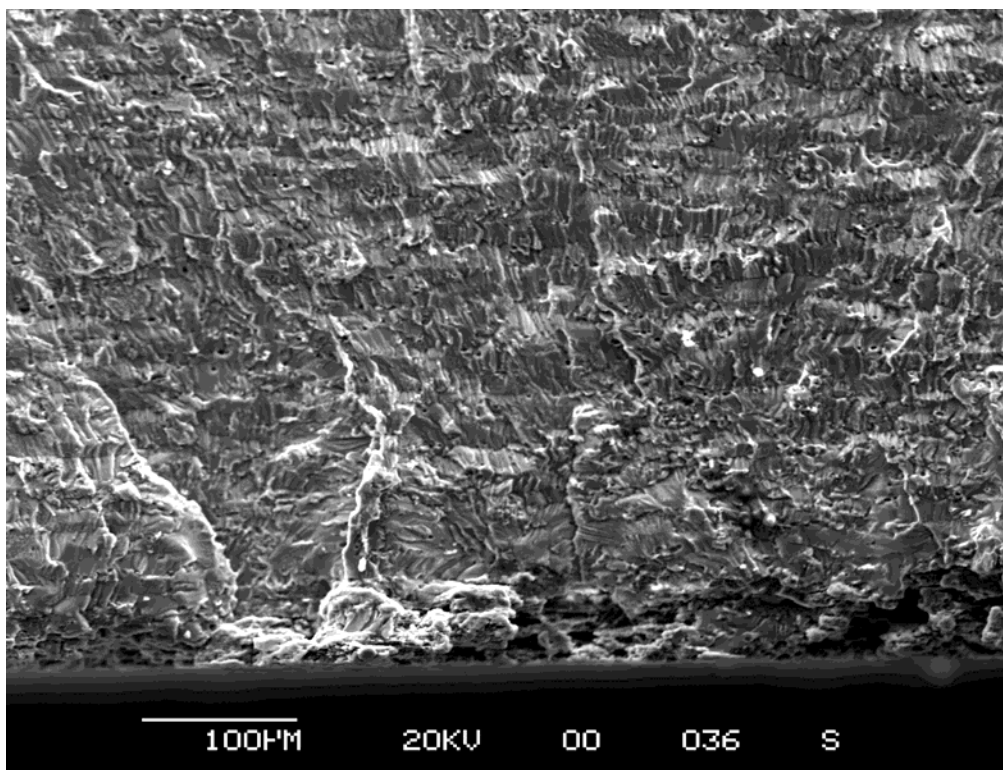
Figure B-36. Crack Origin A (Fig. B-34) on Fracture Surface of Specimen 5877.

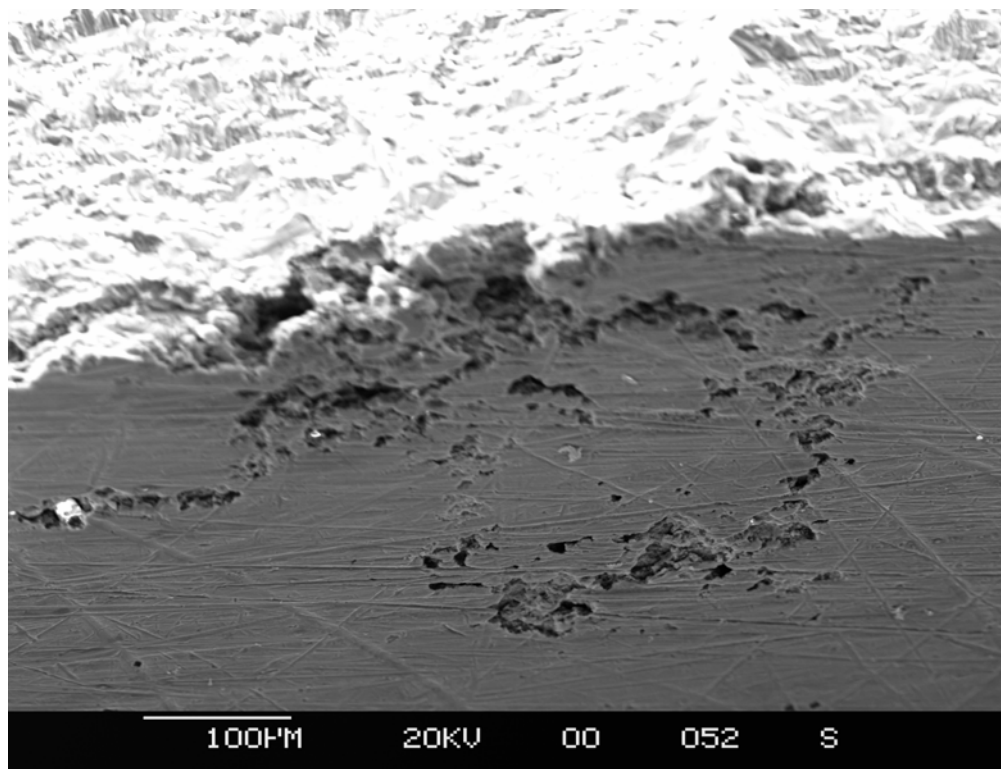
Figure B-37. Surface View of Crack Origin B (Fig. B-34) on Specimen 5877.

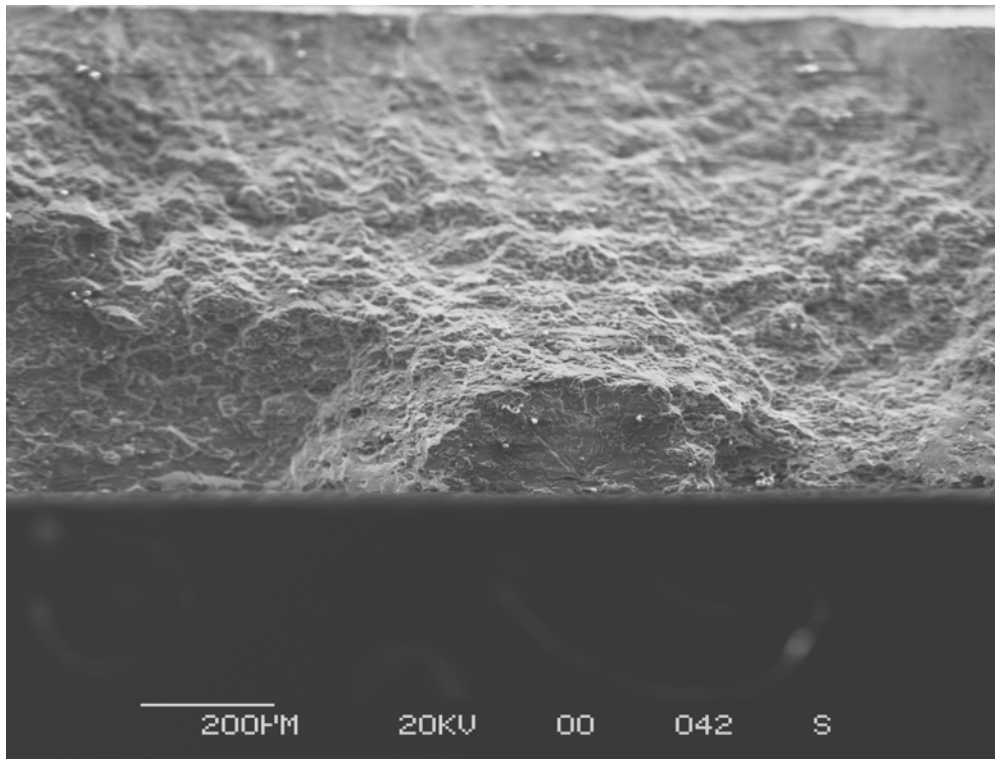
Figure B-41. Third Fatigue Crack on Specimen 5878 to the Right of the Primary Crack in Figure B-39.

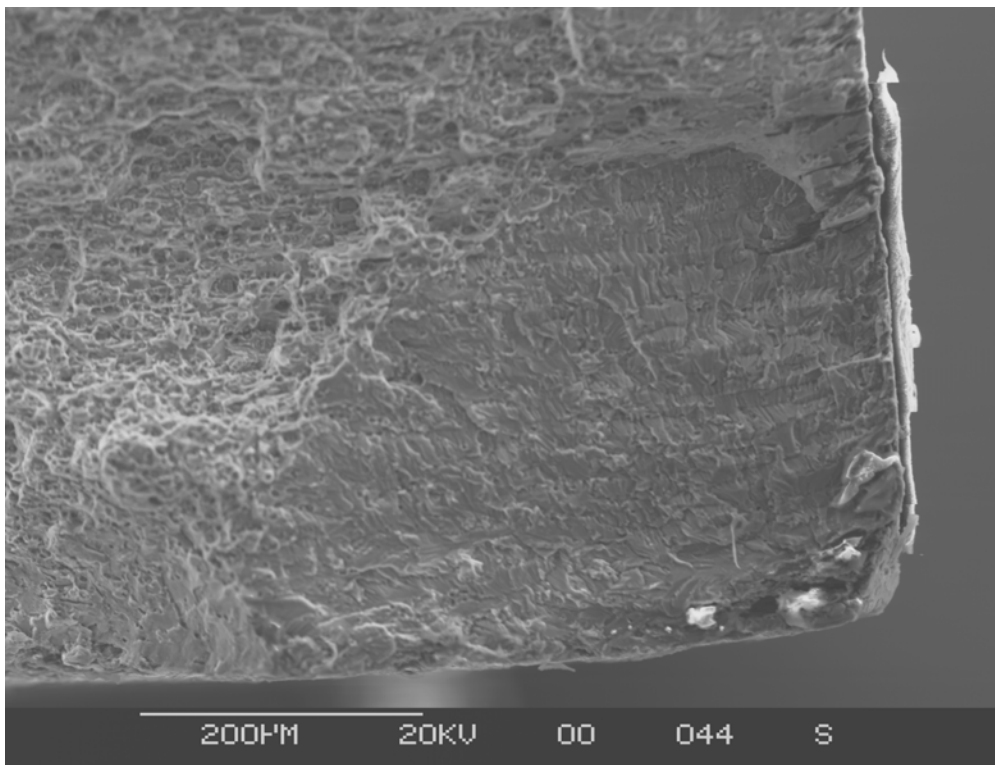
Figure B-42. Fourth Fatigue Crack on Specimen 5878 at the Lower Right Corner of the Specimen Oriented as in Fig. B-39.

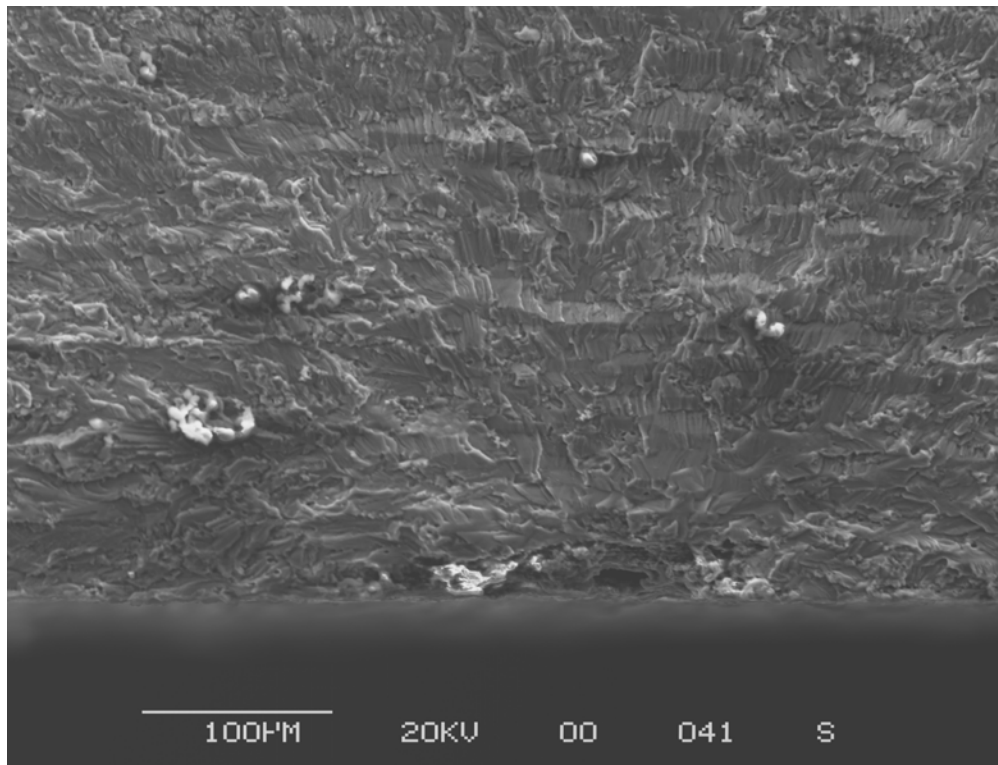
Figure B-43. Origin of Primary Crack in Fig. B-39.

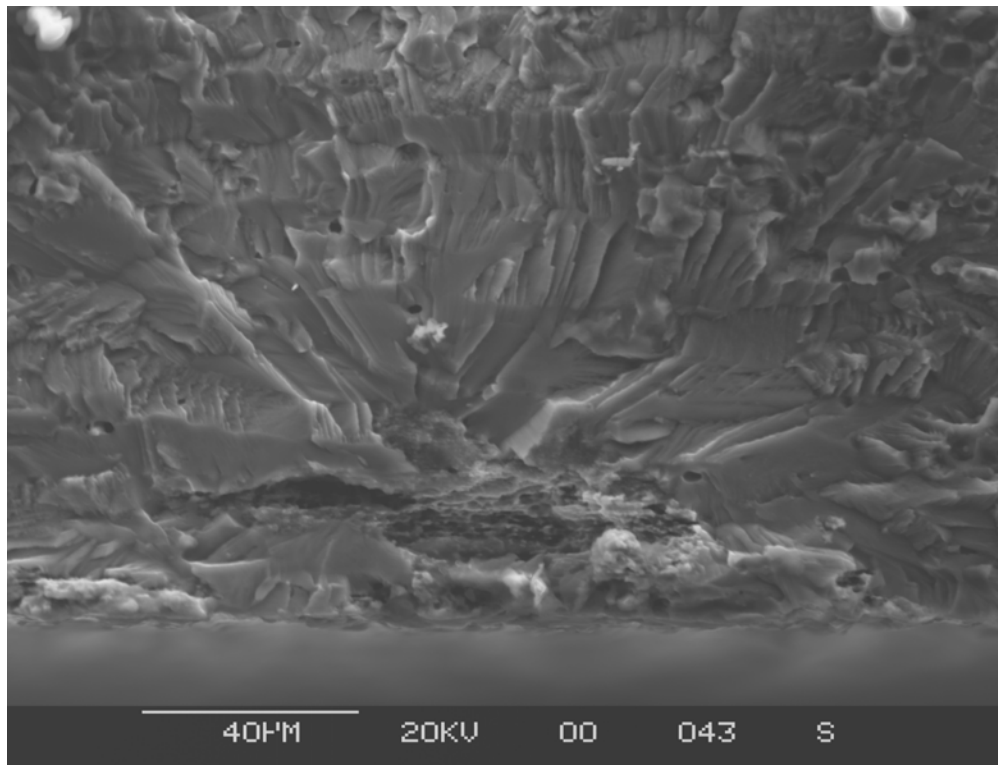
Figure B-45. Origin of Crack in Fig. B-41.

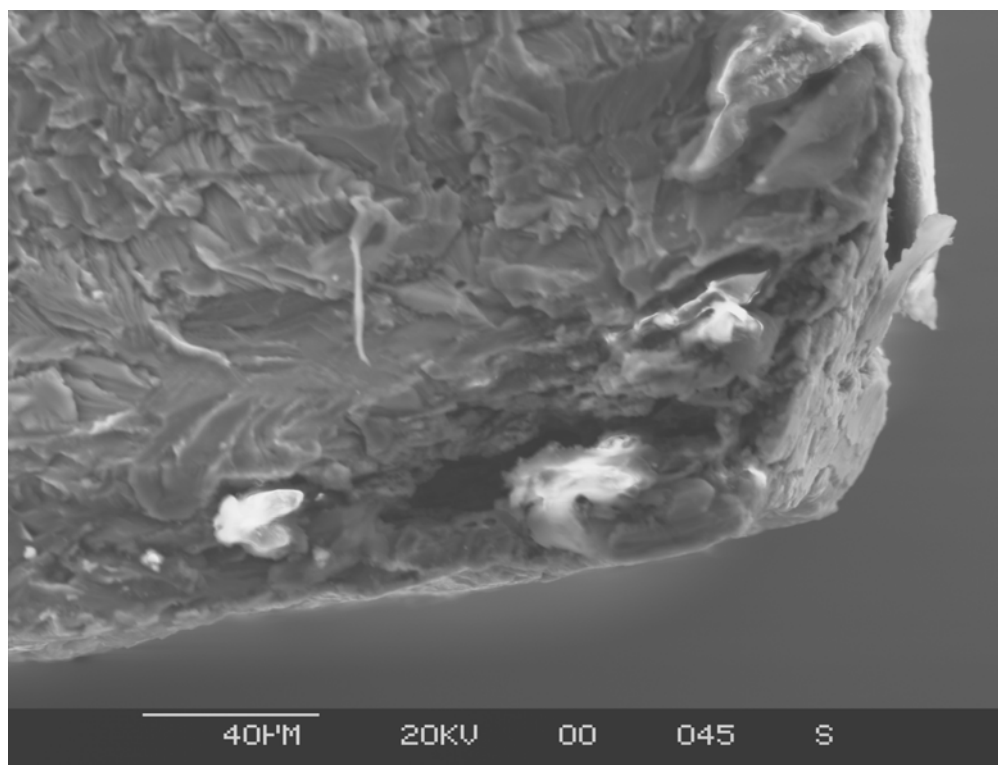
Figure B-46. Origin of Crack in Fig. B-42.

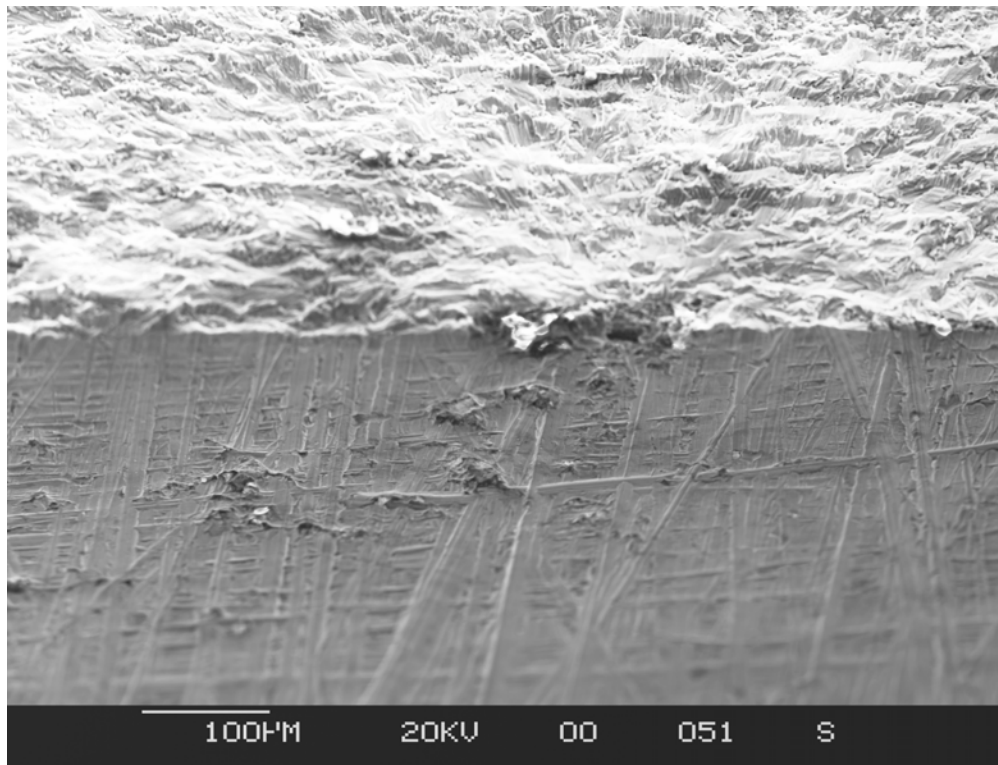
Figure B-47. Front Surface View of Origin of Primary Crack (Fig. B-39).

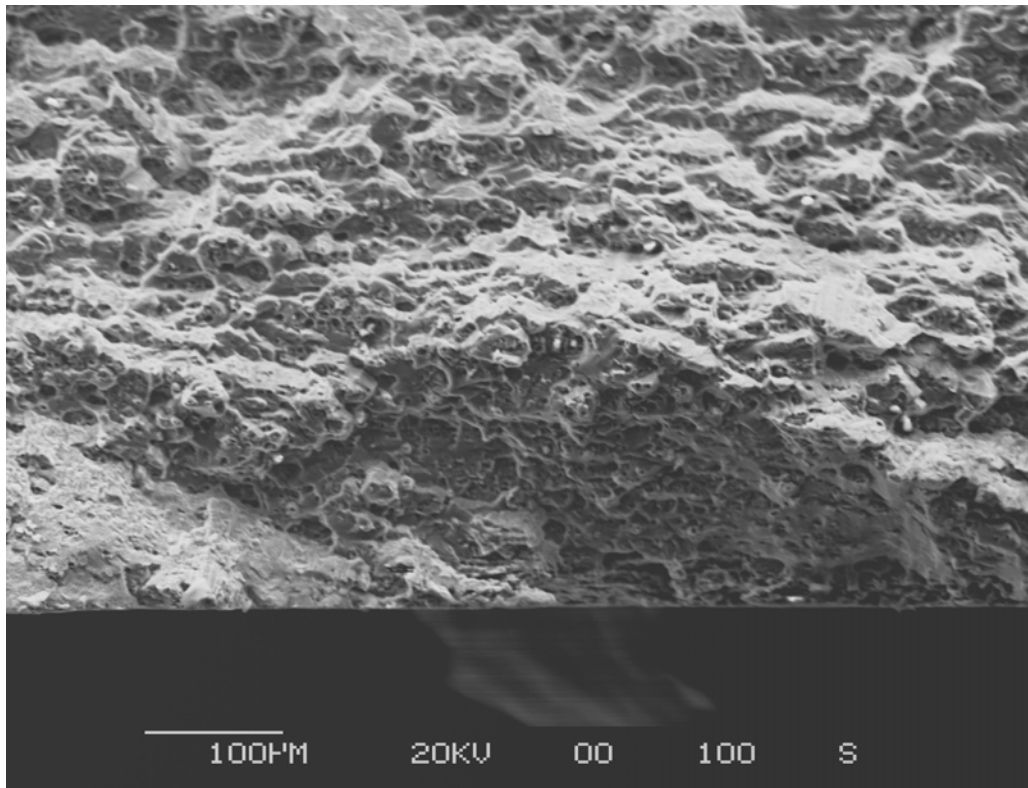
Figure B-49. Origin of Primary Crack on Specimen 5879.

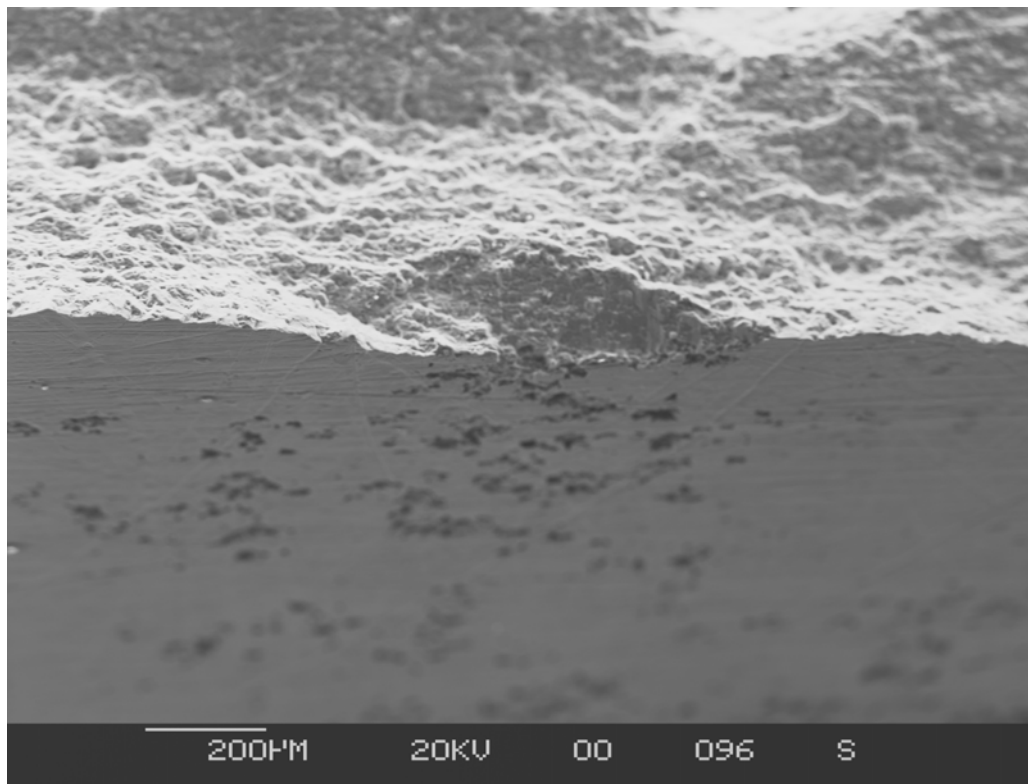
Figure B-50. Surface View of Primary Crack Origin on Specimen 5879.

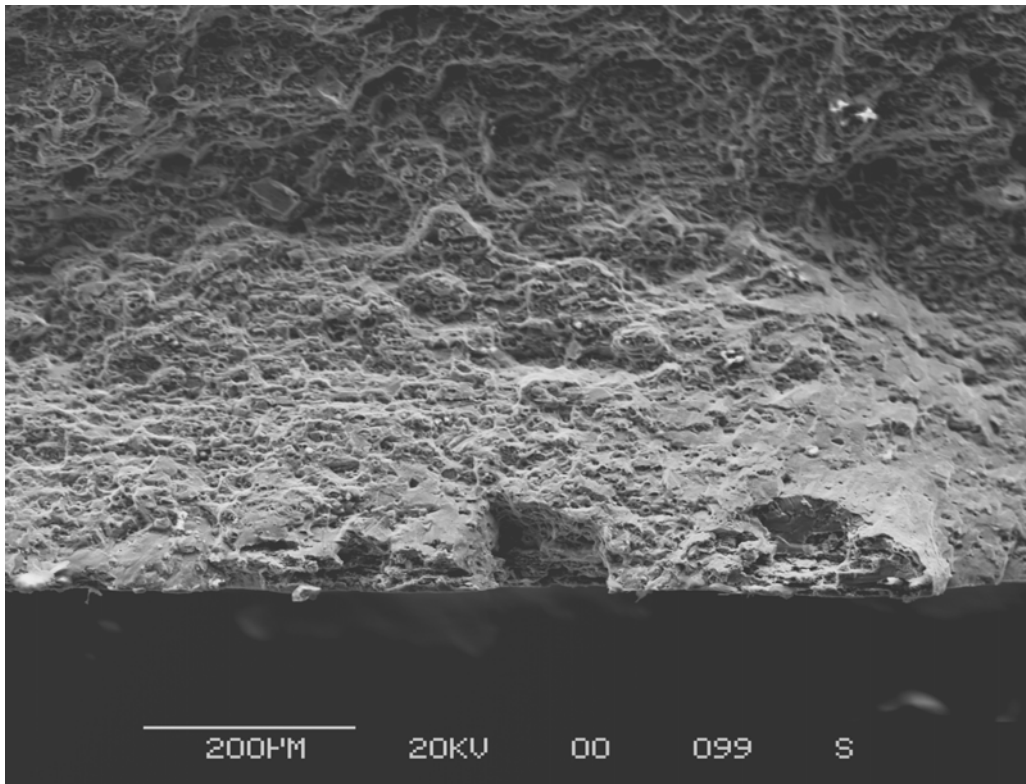
Figure B-51. Secondary Crack Origins on Specimen 5879.

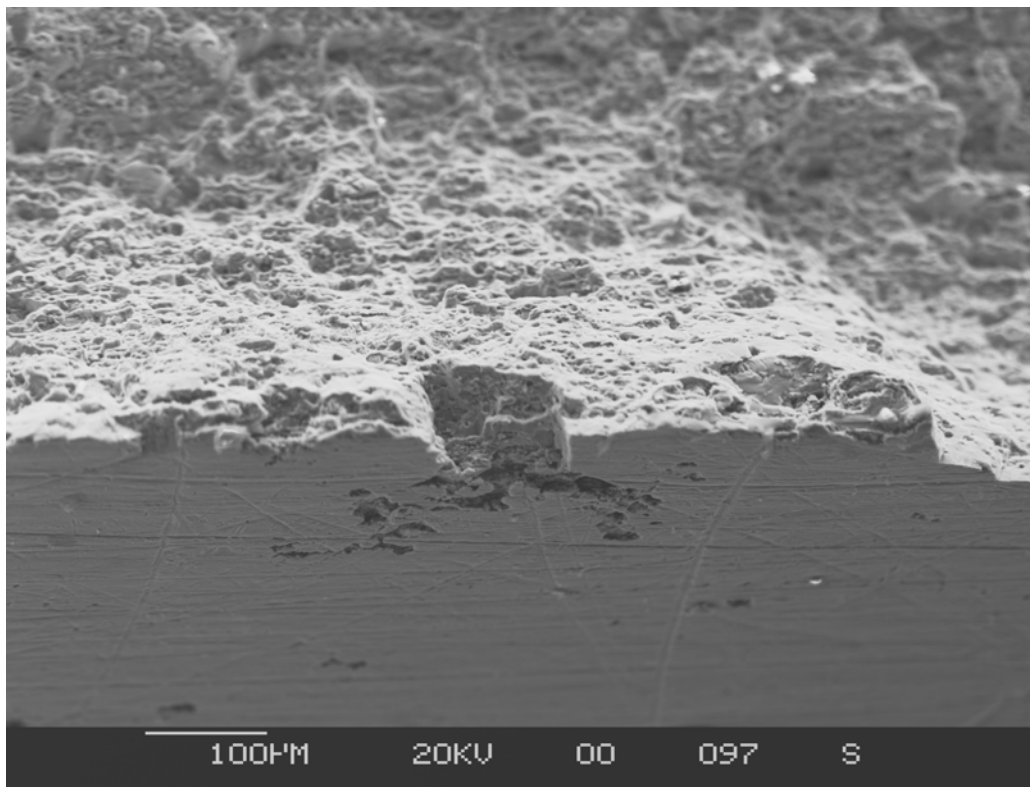
Figure B-52. Surface View of Secondary Crack Origins on Specimen 5879.

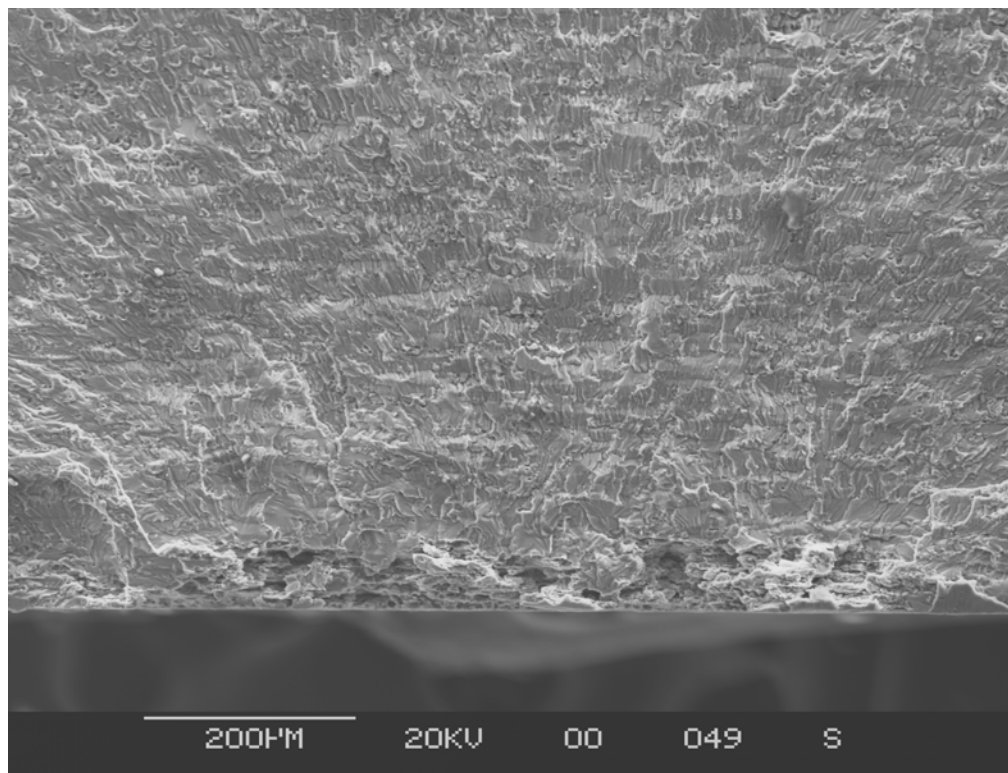
Figure B-54. Origin of Crack on Specimen 5880.

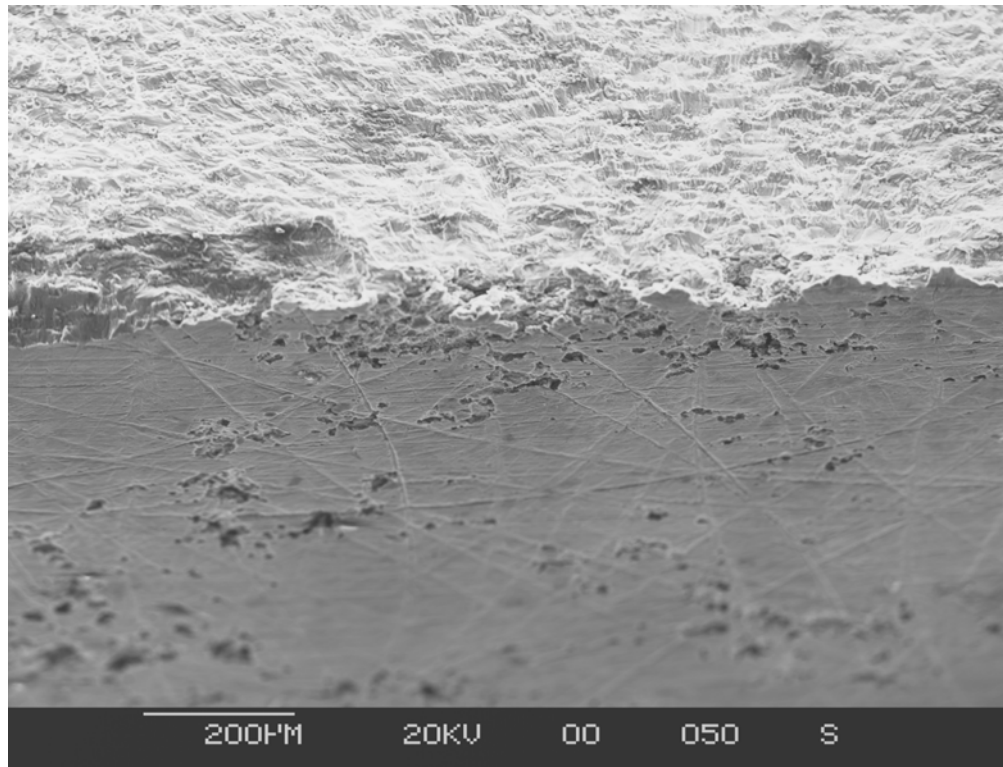
Figure B-55. Front Surface View of Crack Origin on Specimen 5880.
